THAMES RIVER BASIN
DUDLEY, MASSACHUSETTS

MERINO POND DAM
MA 00110

PHASE I INSPECTION REPORT
NATIONAL DAM INSPECTION PROGRAM

SEPTEMBER 1979

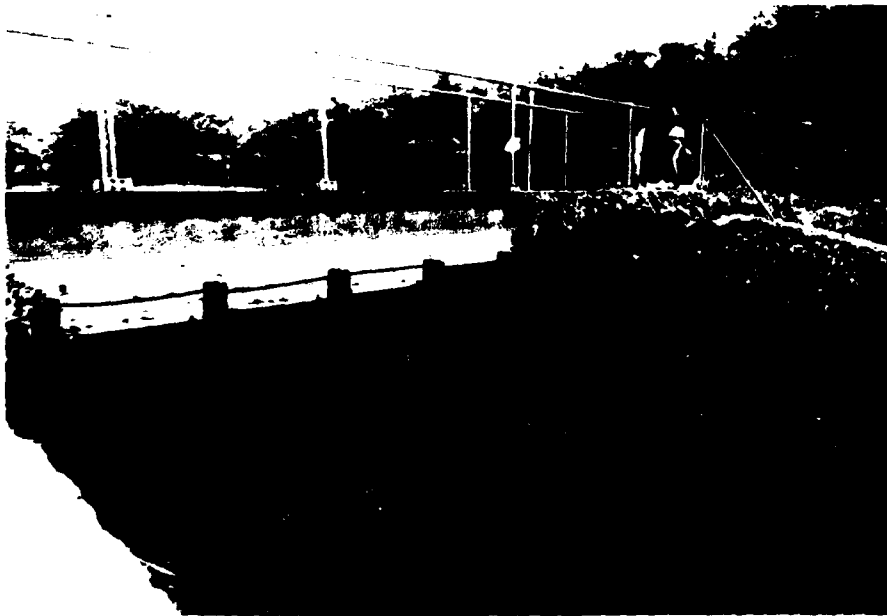
- (2) Footbridge - A footbridge spans the spillway at the upstream side of the dam crest, as shown in Photo 4, and is seated on the spillway training walls. The bridge consisted of two 12 in. deep steel channels which support a wood plank deck and metal pipe handrails. The downstream handrail was noted to be slightly loose. Minor rusting of the channels and the handrails and minor spalling of the left training wall bridge seat were observed.

4. VIEW OF SPILLWAY SHOWING BRIDGE, FLASHBOARDS AND SUPPORTS.

5. Reset displaced stones in the downstream retaining wall.
 6. Repair joints in the spillway retaining walls.
 7. Perform maintenance on the footbridge spanning the spillway in the form of repainting the exterior of the structure, tightening the downstream handrail, and repainting the left bridge seat.

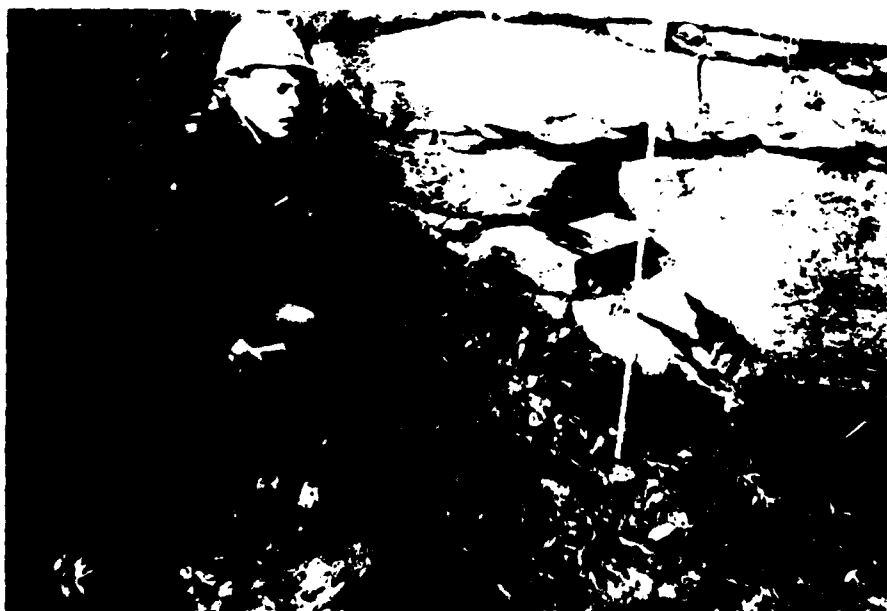
- (2) Seepage was observed at the downstream face at two locations:
 - (a) There was active seepage with rust staining at the toe of the downstream retaining wall to the right of the spillway. (See Photo 8)

8. SEEPAGE NEAR TOE OF DOWNSTREAM FACE OF DAM TO THE RIGHT OF THE SPILLWAY.
